Manhole Inspection Summary

Manhole # S39GG_015MH

Insp Date: **3/28/07 2:06 PM**

Location Address: **1224 TURPIN AVE**

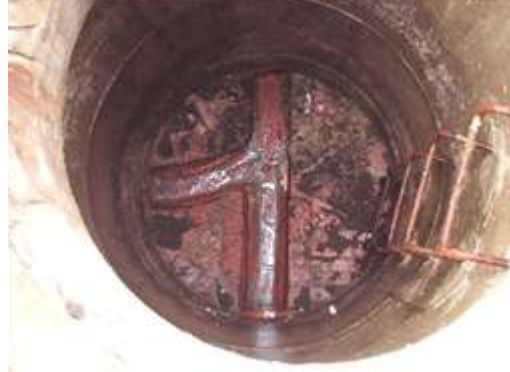
Top View

Corroded steps. Evidence of surcharge - Bench debris.

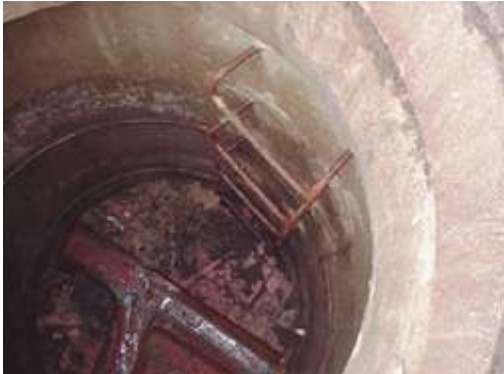
Defect

Frame Offset: **0** (in.) Condition: ☐ Sound ☐ Cracked ☒ **Leaks**

Infiltration: ☐ None ☒ **Joint** ☐ Cracks ☐ Mortar ☐ Roots ☒ **Wall**

Frame leaks. Adjustment, Corbel and Barrel infiltration.

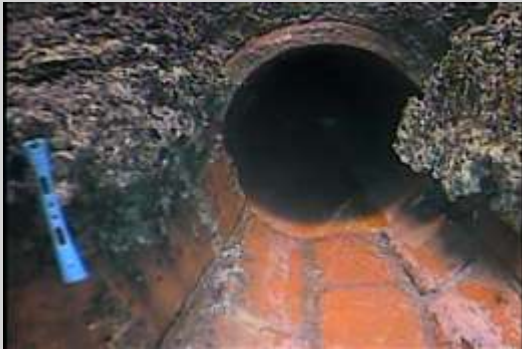
8 in. Circular Gravity Sewer Pipe Out @ 12 O'Clock

Invert Depth: **9.21** (ft.) Flow Characteristics: **Slow**

Infiltration: **None** Pipe Seal Cond: **Unknown**

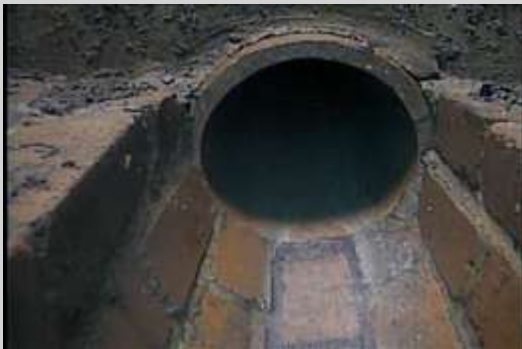
8 in. Circular Gravity Sewer Pipe In @ 6 O'Clock

Invert Depth: **9.04** (ft.) Flow Characteristics: **Slow**

Infiltration: **None** Pipe Seal Cond: **Unknown**

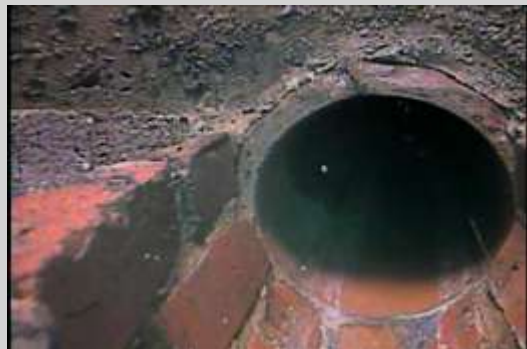
Pipe In @ 9 O'Clock

Invert Depth: **9.13** (ft.) Flow Characteristics: **Slow**

Infiltration: **None**
